**Date:** October 12, 2006

**Equipment:** Unit 3 - Air Preheaters

The purpose of this visit was to complete an inspection of the Ljungström air preheaters on unit 3. The rotors were not rotated during the inspection.

### **Equipment: Two size 30.0-VI-62” Modular Ljungström Air Preheaters**

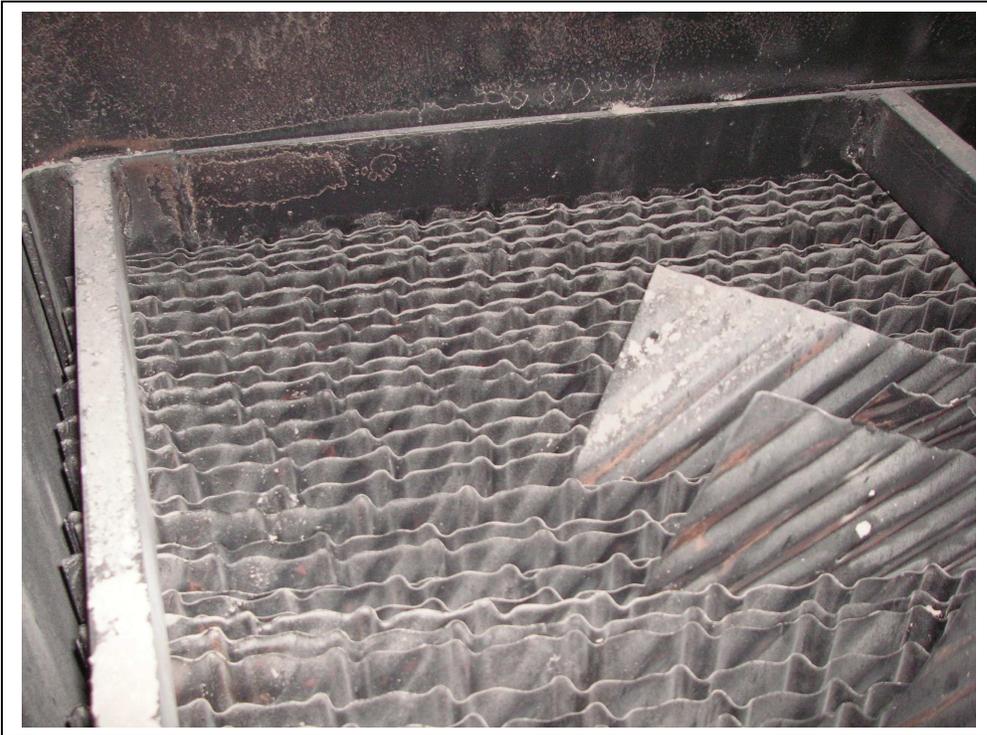
- The hot end element is loose packed DX element. It is breaking up in a manner that is typical of DX element. The undulated sheets are breaking up into small pieces and are coming out of the rotor. The notched and undulated sheets are also failing, but at a slower rate. Three to six inches of depth of the undulated sheets typically have been lost. The inner baskets, A and B baskets are in much better shape than the outer baskets.

**Hot end element damage**

The element failure is typical of DX element, although most DX element fails much quicker. Twenty plus years of service for DX element is extremely good. DX element typically fails as a result of soot blowing. The undulated sheets break into small pieces which fail or blown out of the rotor. With the undulated sheets gone, the remaining notched sheets are much looser which makes them more susceptible to soot blower damage. DX element was replaced with DL element very shortly after it was introduced. DL element has the same undulations and notches as DX. Half of the notches on the DX notched sheet were moved to the undulated sheet to create DL. Adding the notches provided additional stiffness to the undulated sheet to increase its life. DL element will provide the same thermal performance and pressure drop as DX element. The hot end layer of element should be replaced using DL element.

1. The hot end layer of element should be replaced using DL element.
2. The intermediate layer of element should be replaced using DL element.
3. The cold end layer of element should be replaced.

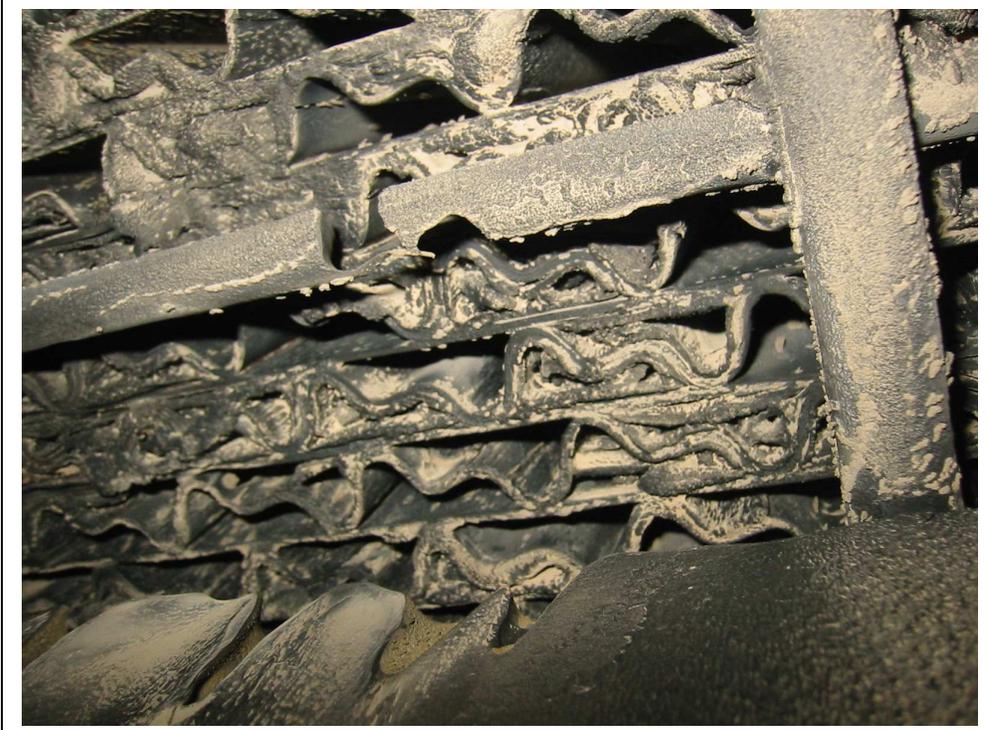
- The cold end element sheets are being eroded on the cold face of the basket. This erosion is more severe in the outer baskets. There is ash build up in the baskets. There is erosion damage to the basket end plates, basket bars and spider bars. Spider bars have been cut in two in places.

**Cold end element pluggage, basket bar erosion and grating erosion**

- The rotors are in relatively good condition. There is erosion damage to the cold end grating which supports the cold end element. The erosion damage, on the top surface of the grating bars, is up to 1” deep.
- The hot end floating T-bar was missing a clip on 3-1. This should be replaced.

The damage to the cold end element is erosion of the element sheets by the soot blower. The areas of the element sheets that are shielded from the direct impact of the soot blowing jet are not eroded as much as the sheets that are protected. The basket bar damage seems to be below the flow passages in the cold end element. Some sections of the rotor are subjected to a greater amount of ash. These areas of greater ash concentration will produce greater damage. The cold end layer of element should be replaced.

The cause of the erosion damage to the grating bars is similar to that of the basket bars. Since the original cold end element lasted 20 plus years, the grating should be replaced.

6. The grating should be replaced.
7. The hot end floating T-bar clip on 3-1 should be replaced.
8. The static seals should be repaired at the inboard and outboard ends.

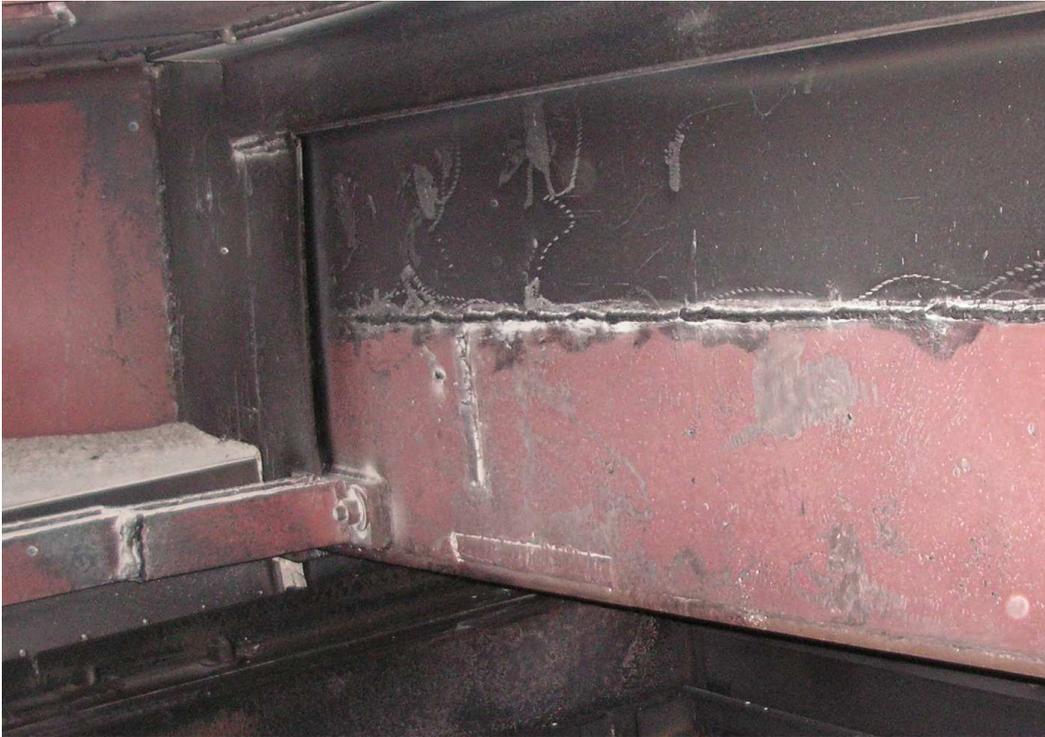
**Static seal gap – outboard end**

Gaps between the static seal and sector plate allow for excess air to gas leakage. The static seals should be repaired.

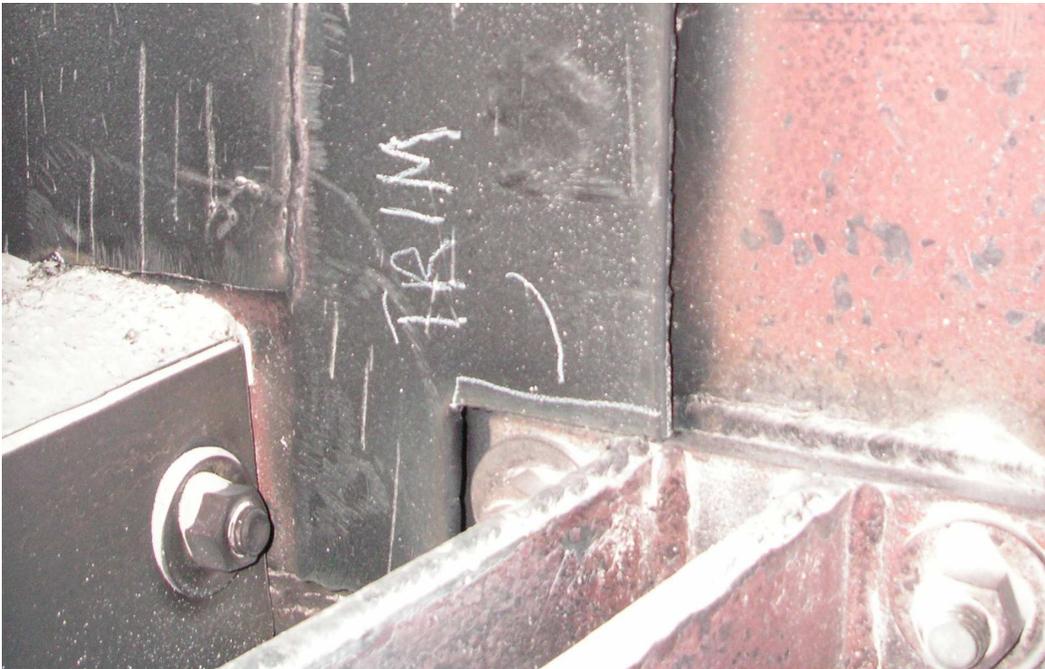
**Static seal bottomed out against the sensor support**

The static seal bottoming out against the sensor support restrict the movement of the sector plate. This is a possible cause for the leakage control system gear box failure. The static seal should be modified to ensure that there is unrestricted movement of the sector plate.

9. The static seal should be modified to ensure that there is unrestricted movement of the sector plate.
10. The erosion damage to the cold end spool should be repaired.

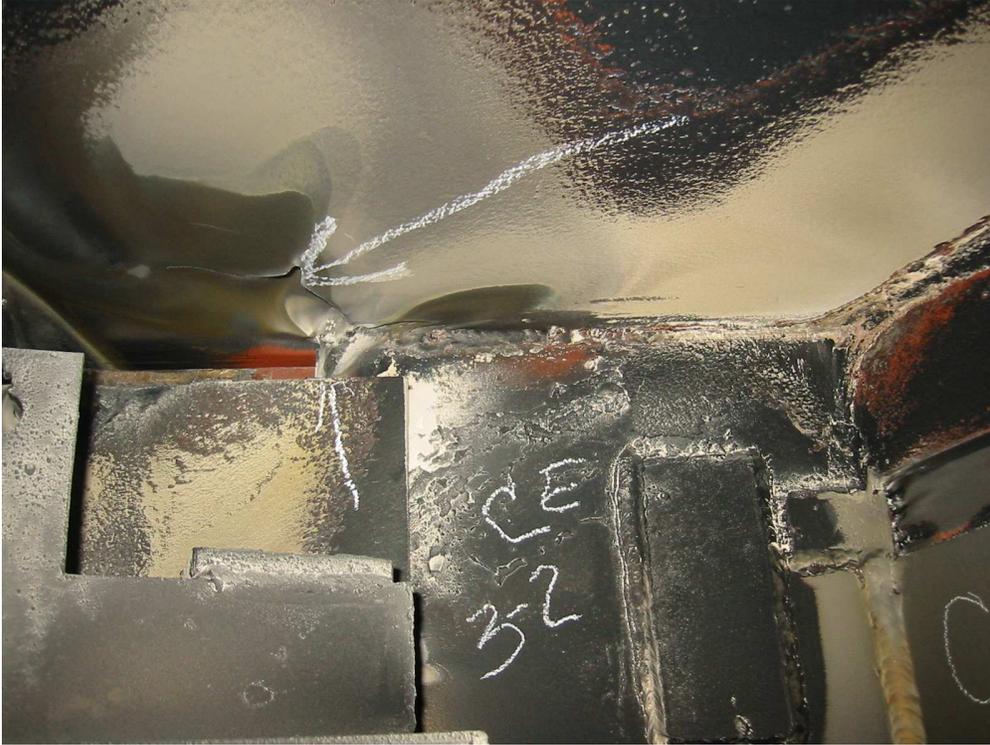
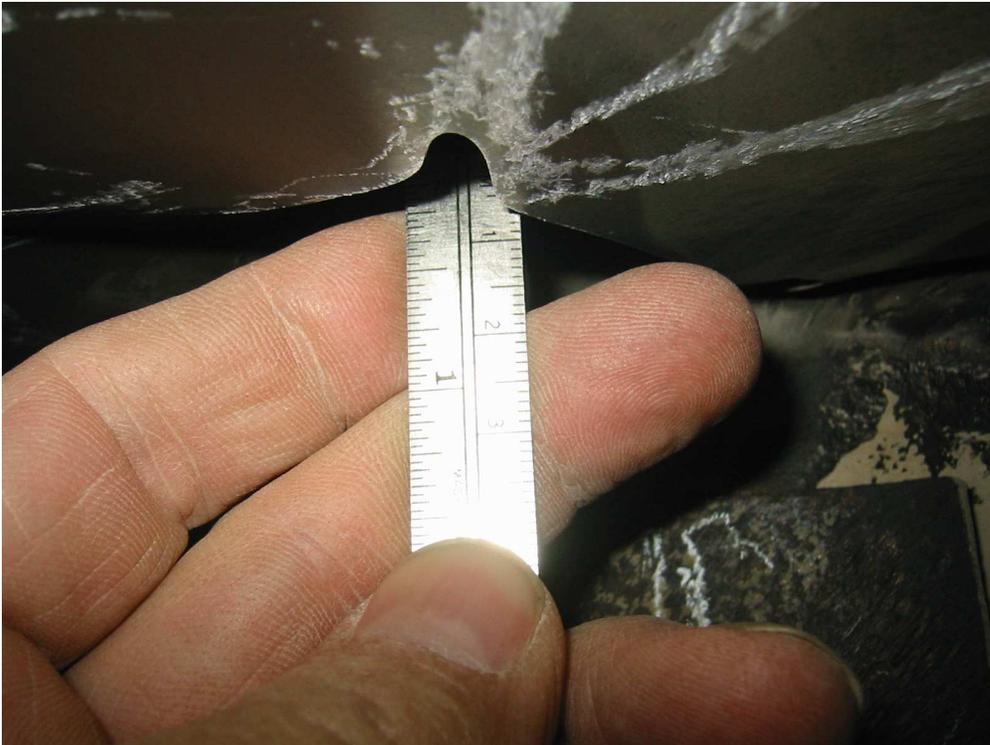
**Cold end spool erosion damage**

There erosion damage to the cold end spool is caused by entrained ash being blown back into the gas duct. If this erosion penetrates the spool plate, the erosion will accelerate and generate higher air to gas leakage. The erosion area should be repaired.

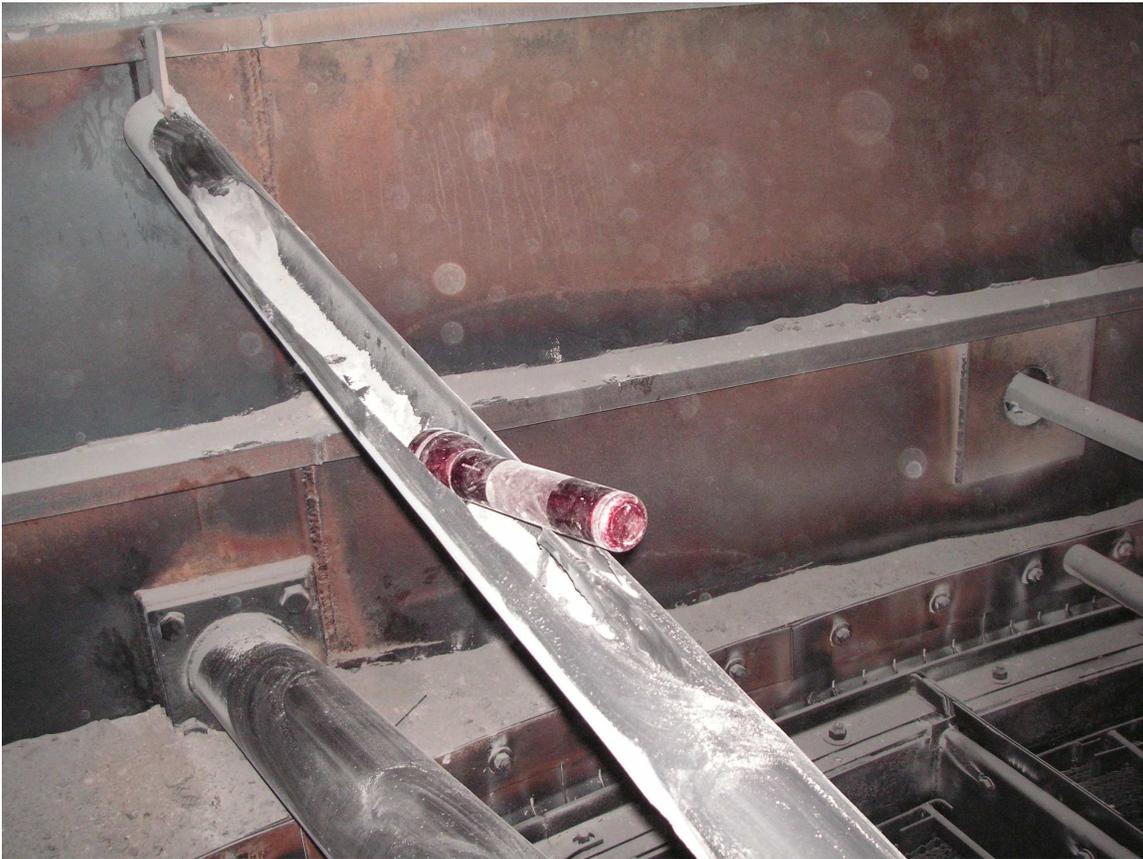
- The hot end pipe bracing in the gas inlet ducts have some erosion damage.
- The beam assemblies in the gas inlet duct that are part of the intermediate pressure high volume washing device are damaged from erosion.
- There are several missing bolts in the air inlet duct, just above the steam coils.
- There are holes in the gas outlet ducts below the rotors.

**Hot end pipe brace erosion damage**

The erosion damage in the gas inlet duct is fairly typical. The pipe braces should be replaced and shielded. Loss of a brace will allow the housing to deform and result in abnormal by-pass seals wear. If the intermediate pressure high volume washing device is used, the beam should be repaired or replaced. Holes in the air inlet and gas outlet ducts should be repaired.

11. The pipe braces should be replaced and shielded.
12. The intermediate pressure high volume washing device support beam should be repaired or replaced if it is used.
