Equipment: Unit 3 - Air Preheaters

Purpose of Visit:

The purpose of this visit was to complete an inspection of the Ljungström air preheaters on unit 3. The rotors were not rotated during the inspection.

Equipment: Two size 30.0-VI-62" Modular Ljungström Air Preheaters

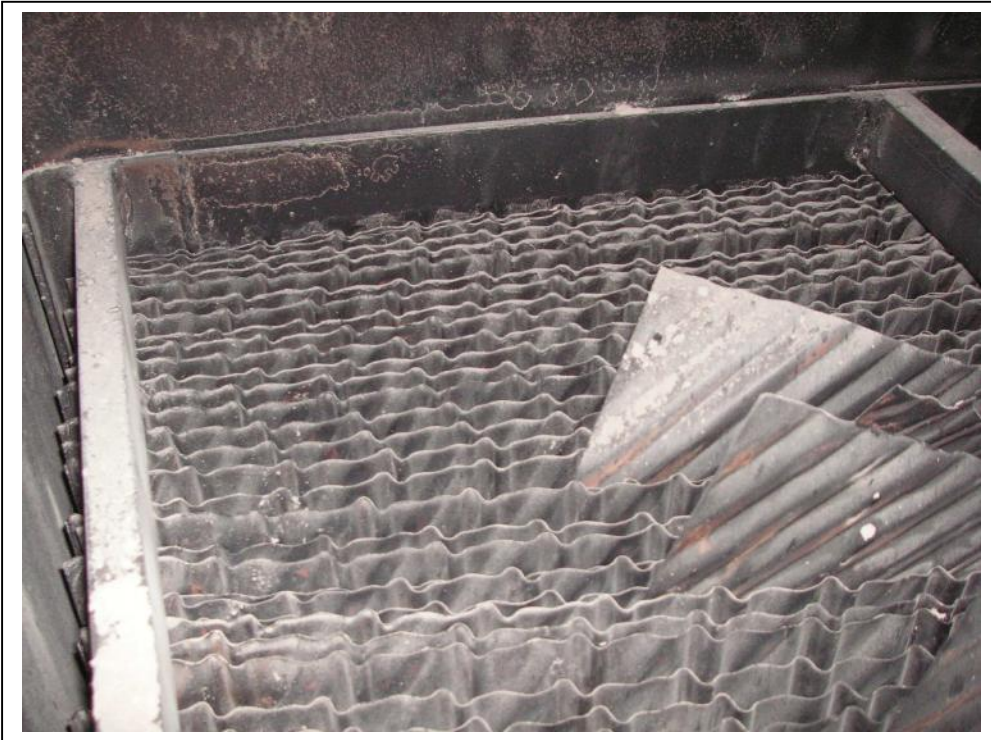
- The hot end element is loose packed DX element. It is breaking up in a manner that is typical of DX element. The undulated sheets are breaking up into small pieces and are coming out of the rotor. The notched and undulated sheets are also failing, but at a slower rate. Three to six inches of depth of the undulated sheets typically have been lost. The inner baskets, A and B baskets are in much better shape than the outer baskets.

Hot end element damage

The element failure is typical of DX element, although most DX element fails much quicker. Twenty plus years of service for DX element is extremely good. DX element typically fails as a result of soot blowing. The undulated sheets break into small pieces which fail or blown out of the rotor. With the undulated sheets gone, the remaining notched sheets are much looser which makes them more susceptible to soot blower damage. DX element was replaced with DL element very shortly after it was introduced. DL element has the same undulations and notches as DX. Half of the notches on the DX notched sheet were moved to the undulated sheet to create DL. Adding the notches provided additional stiffness to the undulated sheet to increase its life. DL element will provide the same thermal performance and pressure drop as DX element. The hot end layer of element should be replaced using DL element.

1. The hot end layer of element should be replaced using DL element.
2. The intermediate layer of element should be replaced using DL element.
3. The cold end layer of element should be replaced.

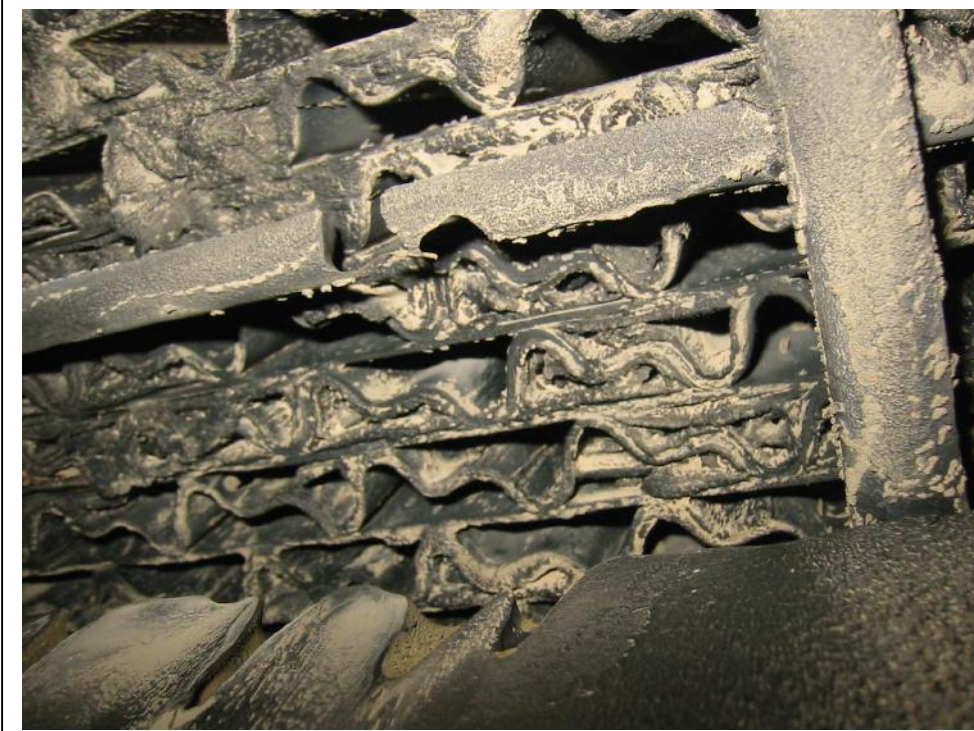
- The cold end element sheets are being eroded on the cold face of the basket. This erosion is more severe in the outer baskets. There is ash build up in the baskets. There is erosion damage to the basket end plates, basket bars and spider bars. Spider bars have been cut in two in places.

Cold end element pluggage, basket bar erosion and grating erosion

- The rotors are in relatively good condition. There is erosion damage to the cold end grating which supports the cold end element. The erosion damage, on the top surface of the grating bars, is up to 1" deep.
- The hot end floating T-bar was missing a clip on 3-1. This should be replaced.

The damage to the cold end element is erosion of the element sheets by the soot blower. The areas of the element sheets that are shielded from the direct impact of the soot blowing jet are not eroded as much as the sheets that are protected. The basket bar damage seems to be below the flow passages in the cold end element. Some sections of the rotor are subjected to a greater amount of ash. These areas of greater ash concentration will produce greater damage. The cold end layer of element should be replaced.

The cause of the erosion damage to the grating bars is similar to that of the basket bars. Since the original cold end element lasted 20 plus years, the grating should be replaced.

6. The grating should be replaced.
7. The hot end floating T-bar clip on 3-1 should be replaced.
8. The static seals should be repaired at the inboard and outboard ends.

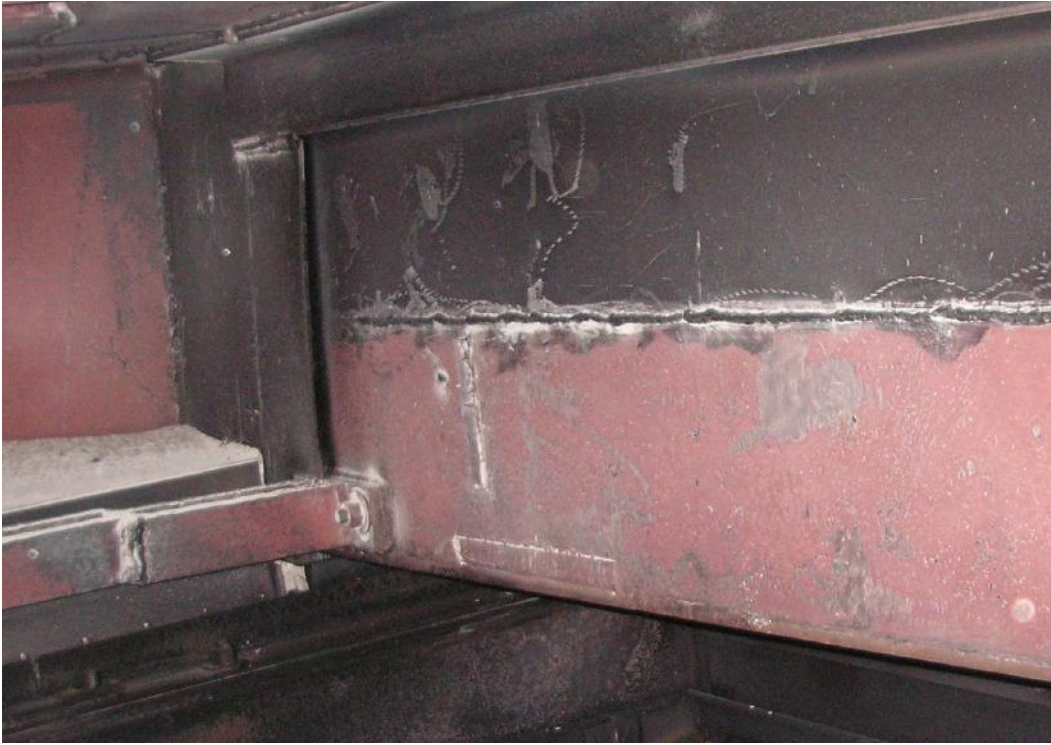
Static seal gap – outboard end

Gaps between the static seal and sector plate allow for excess air to gas leakage. The static seals should be repaired.

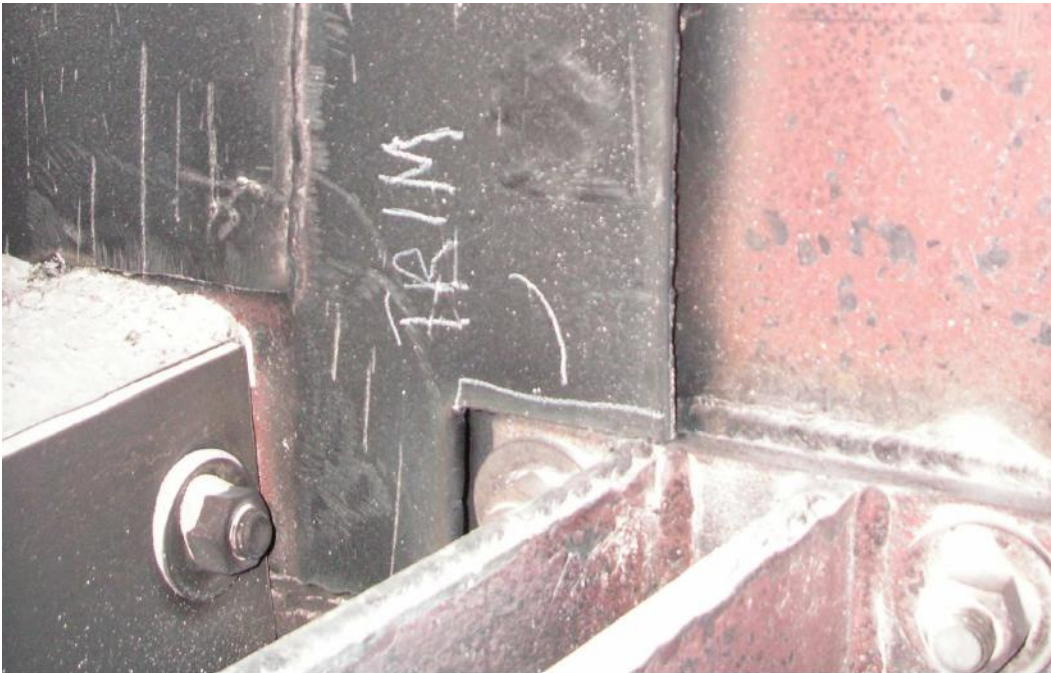
Static seal bottomed out against the sensor support

The static seal bottoming out against the sensor support restrict the movement of the sector plate. This is a possible cause for the leakage control system gear box failure. The static seal should be modified to ensure that there is unrestricted movement of the sector plate.

9. The static seal should be modified to ensure that there is unrestricted movement of the sector plate.
10. The erosion damage to the cold end spool should be repaired.

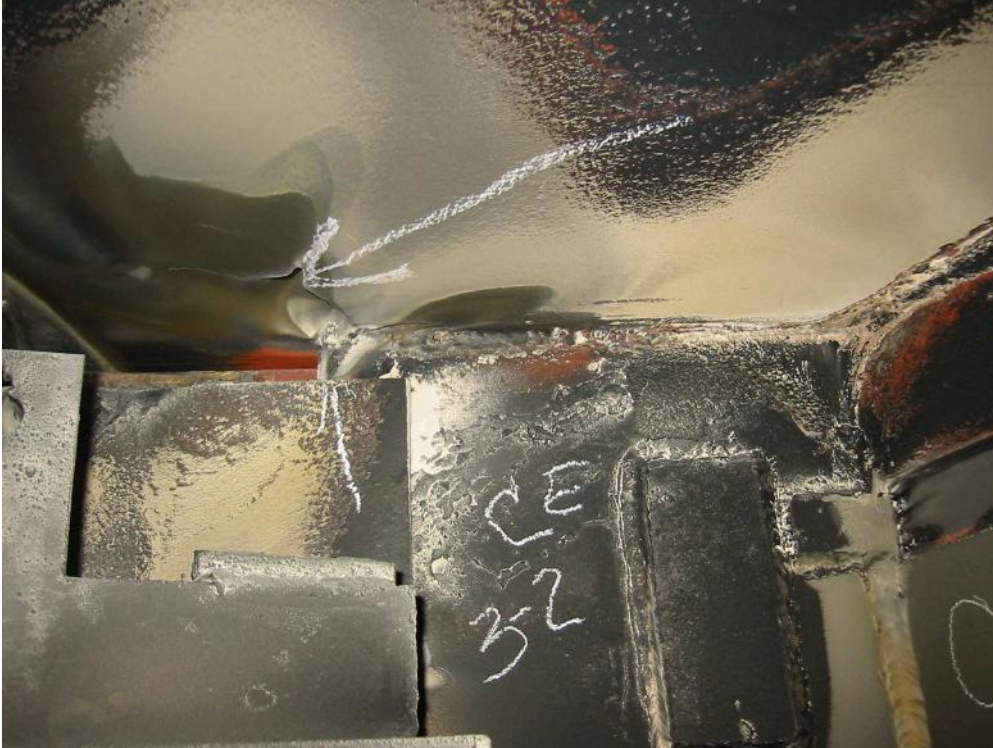
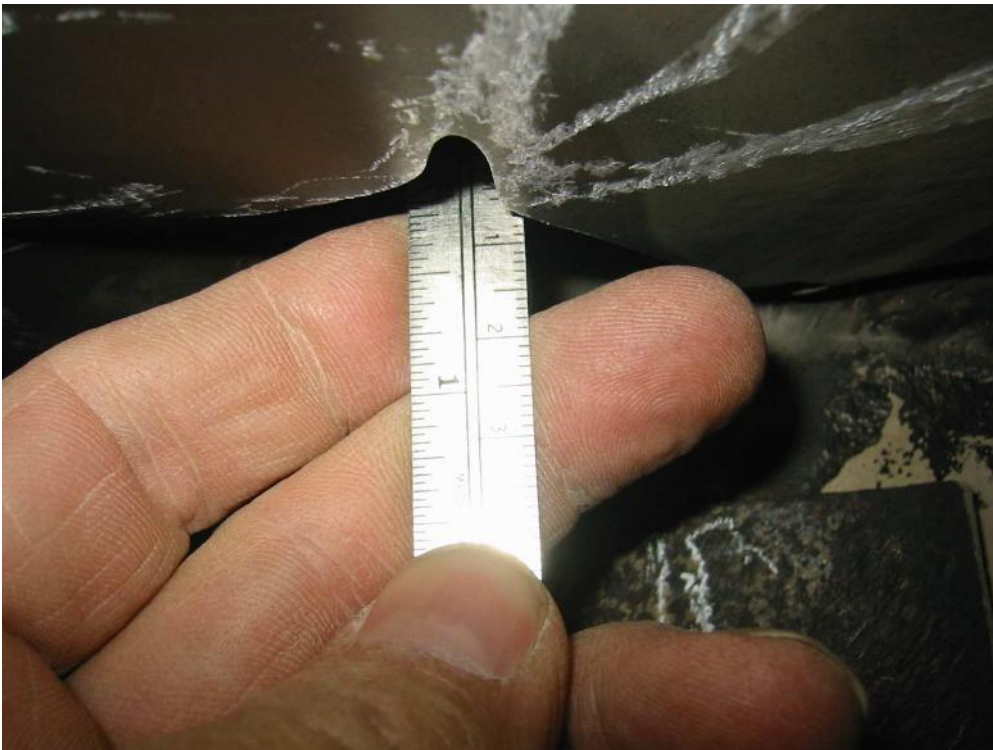
Cold end spool erosion damage

There erosion damage to the cold end spool is caused by entrained ash being blown back into the gas duct. If this erosion penetrates the spool plate, the erosion will accelerate and generate higher air to gas leakage. The erosion area should be repaired.

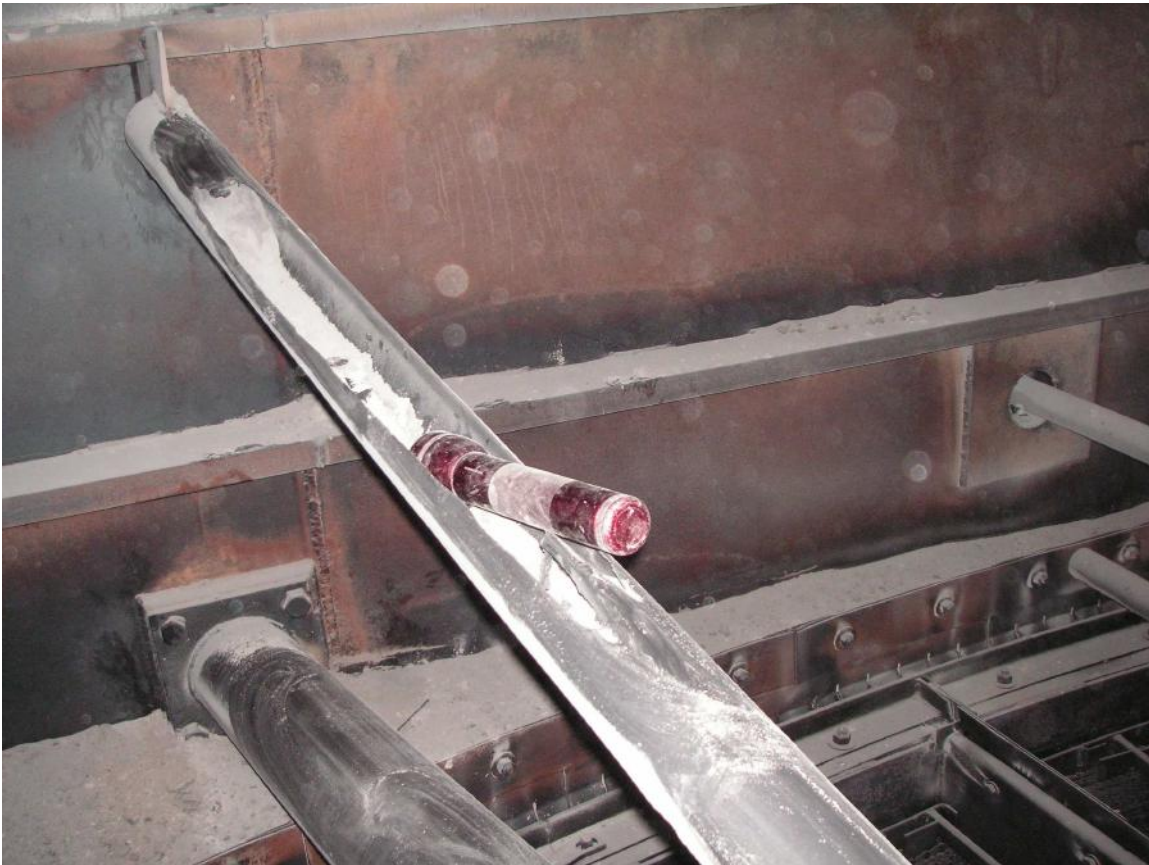
- The hot end pipe bracing in the gas inlet ducts have some erosion damage.
- The beam assemblies in the gas inlet duct that are part of the intermediate pressure high volume washing device are damaged from erosion.
- There are several missing bolts in the air inlet duct, just above the steam coils.
- There are holes in the gas outlet ducts below the rotors.

Hot end pipe brace erosion damage

The erosion damage in the gas inlet duct is fairly typical. The pipe braces should be replaced and shielded. Loss of a brace will allow the housing to deform and result in abnormal by-pass seals wear. If the intermediate pressure high volume washing device is used, the beam should be repaired or replaced. Holes in the air inlet and gas outlet ducts should be repaired.

11. The pipe braces should be replaced and shielded.
12. The intermediate pressure high volume washing device support beam should be repaired or replaced if it is used.
