“3D” Inspection Report

**Unit 2 Airheaters
Outage May 7, 20XX**

**XXXXXXXXXX Co.
XXXXXXXXXX Station
Plant Contact: _____**

**By: XXXXXXXXXXX XXXXXXX
Field Services**

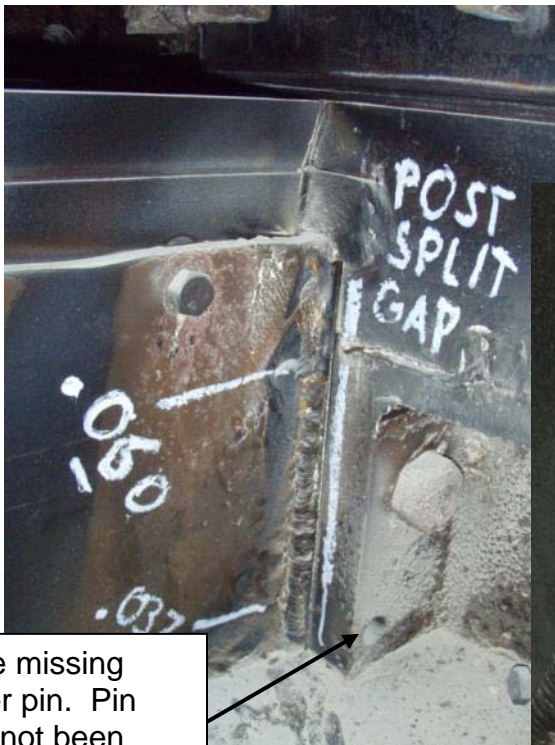
Note missing taper pin. Pin has not been sheared. It has worked loose.

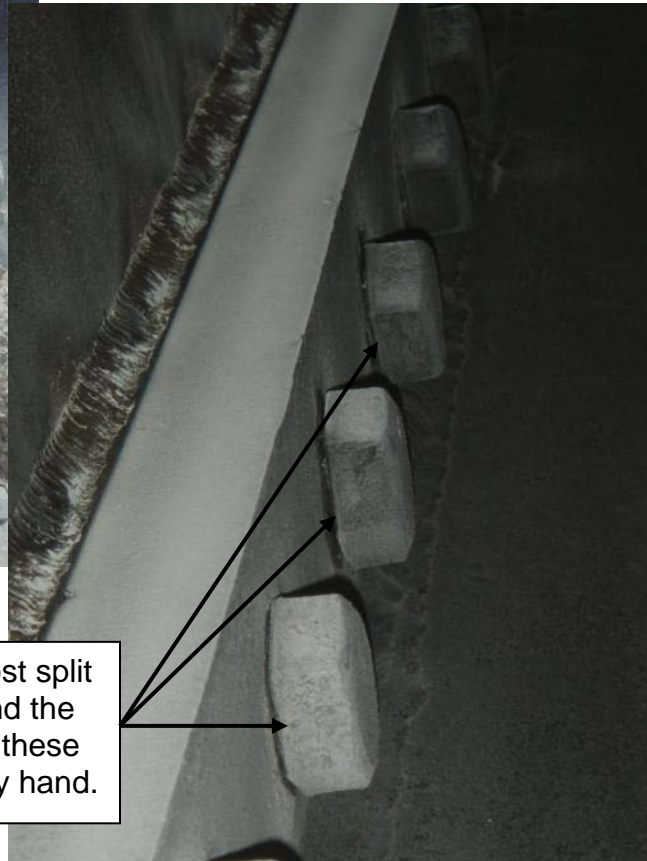
The Rotor Posts on both primaries had a .030-.060" gap between the Rotor Post halves. This was not a crack, but a gap between the mating surfaces of the post halves. Subsequent investigations found the gap to be uniform all the way up the length of the Rotor Posts. Additionally, the majority of the Rotor Post flange bolts were loose. (See Photos)

Note gap between post split flange bolt heads and the flange. Nearly all of these bolts could be spun by hand.

- **Area:** 2A Primary Rotor Post split.
- **Action:** Replace Bolts, retorque.
- **Cause:** Unknown
- **Repair:** Replace and retorque Rotor Post flange bolts with A325 or equivalent 1.25 x 7 UNC bolts. Torque to 1120 Ft/Lbs in three incremental steps. (700, 900, 1120 ft/lbs) Alternate torquing sequence on last 2 steps. Once torqued, it is advised that the Rotor Post mating flanges be seal welded using 7018 or 8018 welding electrode with the proper preheat for parent material of this thickness.

When this operation is complete, the trunnion bolts on both hot and cold ends should be removed, replaced with new bolts, and re-torqued to OEM specified values. **(This is a precautionary measure. There was no damage noted during the inspection, but the movement of the rotor halves would have exerted considerable lateral force on the trunnion bolts themselves.)**

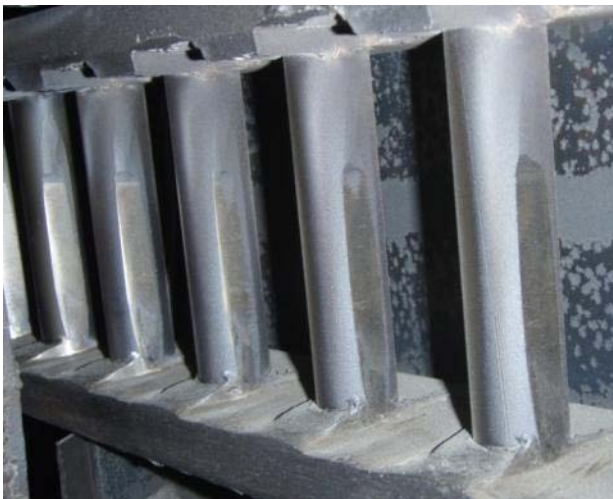
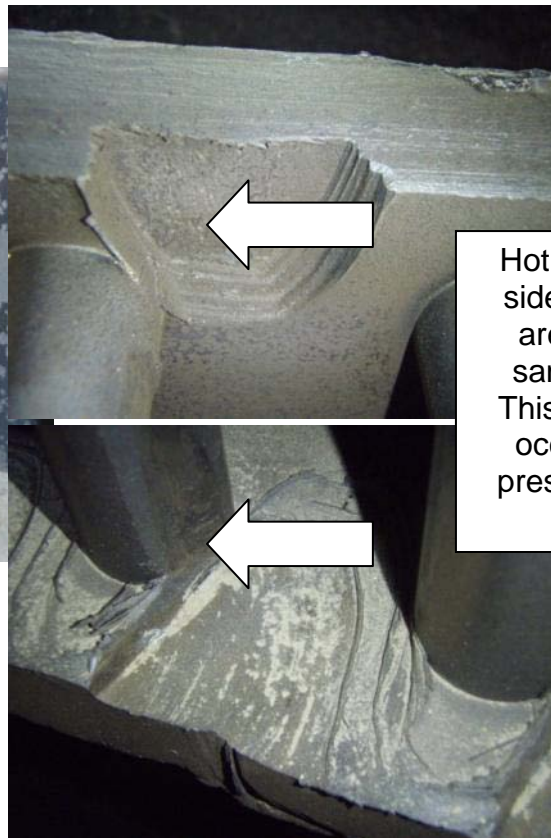
We found no evidence that any of the trunnion bolts had broken or loosened, but the pinrack on both primaries has Pinion Gear impingement wear on both the hot and cold end side rails within the same pinrack section. (See Photo) Normally when I see wear on both siderails in one section of pinrack it's a good indicator that the pinrack has been flipped, or removed and turned over to take advantage of the opposing wear surfaces. This will produce wear on both side rails, but the wear will be on the opposite sides of the pin. In both primaries, hot and cold side rail wear is on the same side of the pin indicating that the load has been in the same direction when the Pinion Gear contacted the rail. This precludes the flipping theory.

Hot and cold end side rail damage are both in the same direction. This damage has occurred in the present mounting

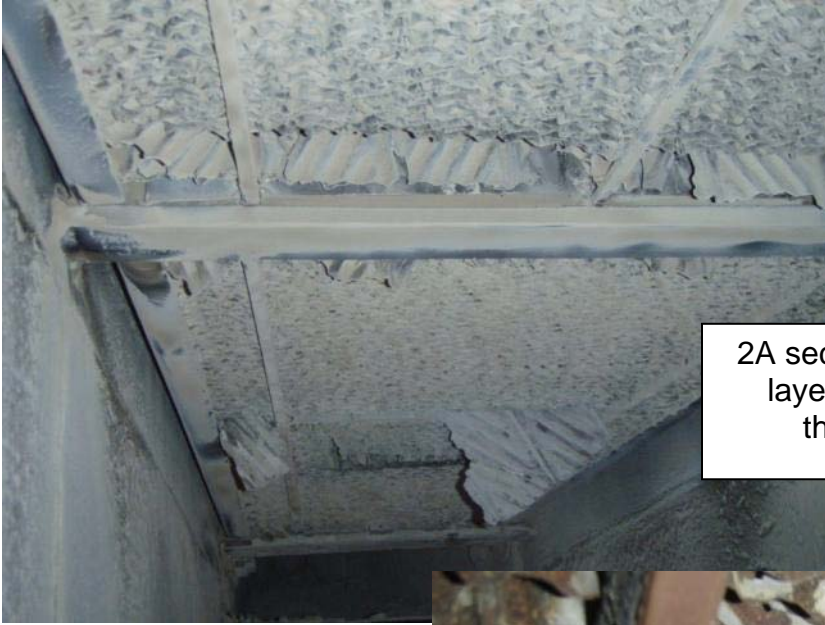
- Intermediate baskets: **Primaries:** Not inspected. **Secondaries:** The 2A secondary intermediates were the only baskets available for inspection. Noted significant element drop and thinning/cracking in the intermediate element. Given consistent operating characteristics, it would be reasonable to assume that the 2B secondary intermediate baskets are in similar condition. (See Photos next page)

2A secondary intermediate layer element loss and thinning/cracking.

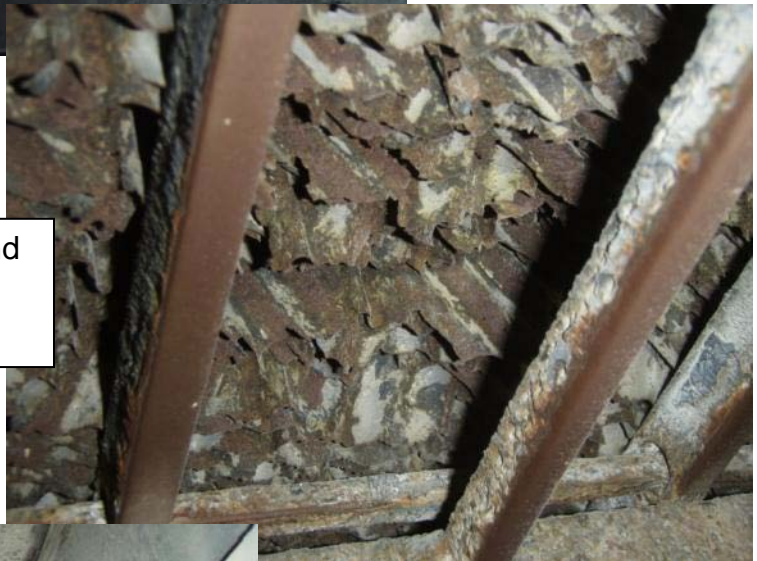
- Cold end Baskets and support grating: **Primaries:** Cold end baskets and support grating on both primaries were in excellent condition. Grating was full thickness and free from significant erosion damage and cracks. Baskets were NF-6 type element 18 Ga. The element is clean and free thinning/spiking. **Secondaries:** Cold end grating is very thin. Cold end element of the DL loose pack type is severely thinned and spiking. (See Photos next page)

2B Secondary cold end DL element severely thinned and spiking.

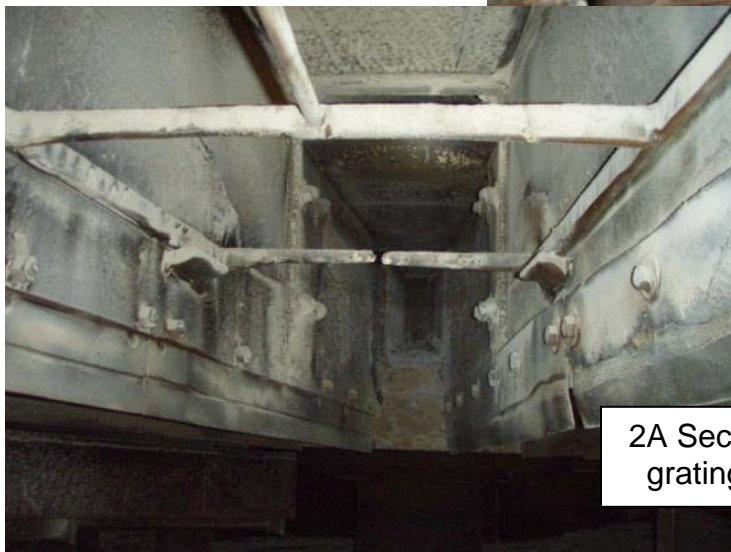
2A Secondary cold end support grating thinned and cracking.

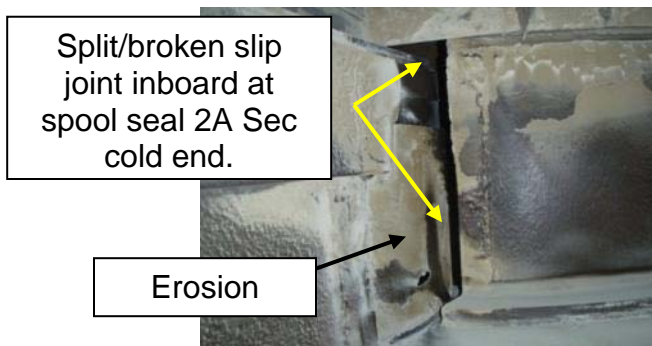
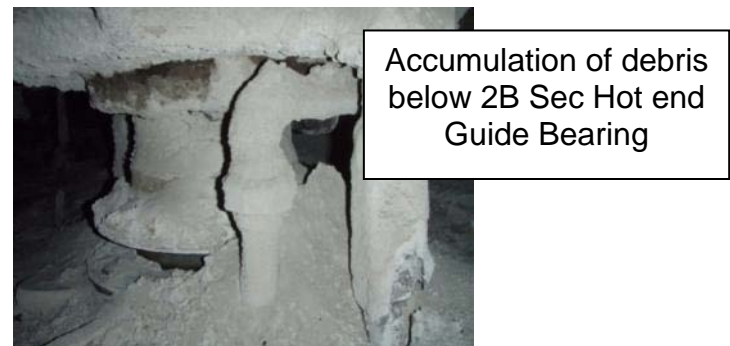
Static seals on the hot and cold end gas side of both the Sector Plates and Axial Seal Plates of all Rotors have both cracks and erosion damage. (See Photo) This is normal, but should be addressed promptly to prevent damage to the underlying Sector Plate and center section structure, as well as to limit the accumulation of debris between the Sector Plates and the center section.

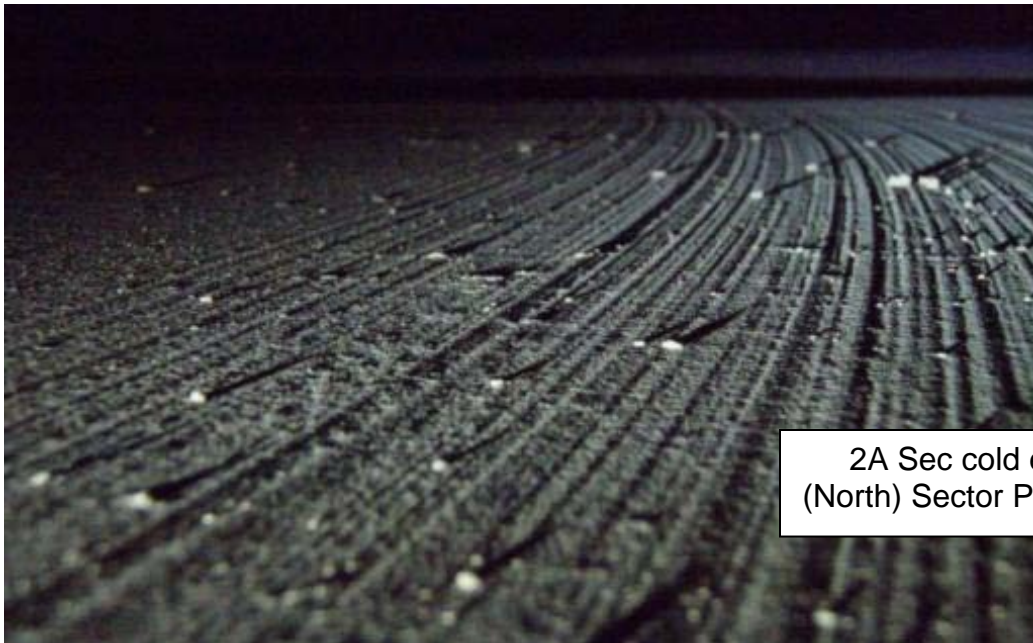
- "*" Indicates that the Sector Plate adjusting bolt below this area was found to be loose. The inboard adjusting bolt will have an effect on both inboard measurements for a given Sector Plate since it is the only mounting point for the nose of the plate.
- Hot and cold end Sector Plates were in good condition with relatively minimal signs of heavy contact wear or erosion with the exception of the following:
- Cold end Gas-to-Air Sector Plate shows signs of moderate contact wear. It is not localized and is not of significant depth to be a major concern. (See Photo)

2A Sec cold end Gas-to-Air
(North) Sector Plate contact wear.

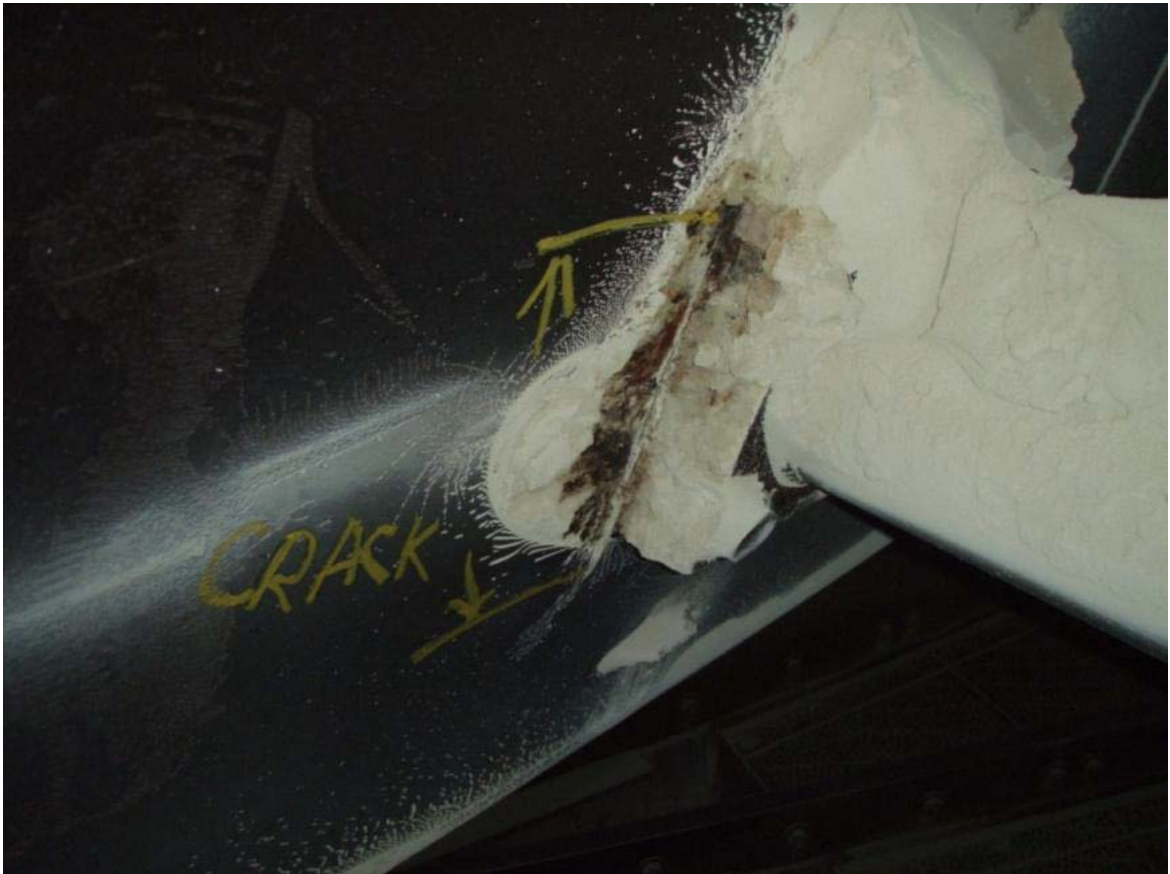
Hot end inboard pipe brace mounting pads on both 2A Secondary Hot end air side, and 2B Secondary Hot end gas side had cracked welds. (See Photo)
Work orders have been initiated in the Work Order section for each unit.

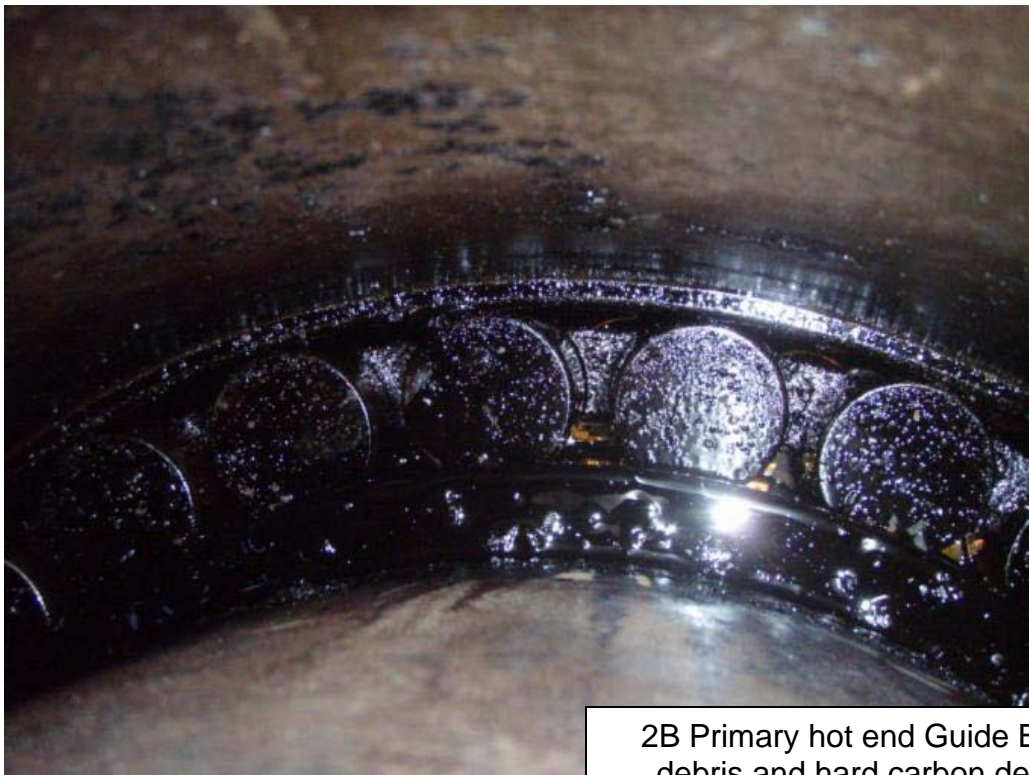
SKF 23000 series double spherical roller type: All Guide Bearings covers were removed for inspection. Radial clearances were not consistent with this size bearing. It is assumed that the races are loaded from the Sector Plate tracking rod yoke. In any case, readings obtained with the bearing in this position are unreliable. Bearing internal inspections yielded nothing out of the ordinary. Rollers were free from cracks, galling or other deformity. Races had the normal burnished annular rings of contact but no palpable wear or defects. Roller cages were intact and did not have excessive play. 2B Primary guide bearing was the worst in terms of debris and “coking”. (See Photo) Bearing was solvent cleaned/flushed, then flushed with 32wt hydraulic oil, drained and refilled with the proper lubricant. All other Guide Bearings were drained and refilled pursuant to the inspection.

2B Primary hot end Guide Bearing
debris and hard carbon deposits

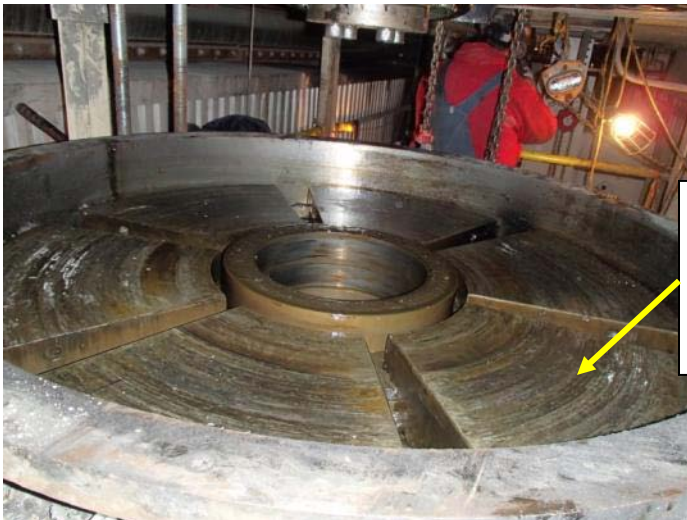
1. Thrust shoes were finely galled over 100% of their contact area. (See Photos below).
2. Thrust runner was in good condition, with no immediate signs of damage to the wear surface. It is to be sent out for resurfacing with the shoes.
3. Upper/lower leveling plates and pivot rods appear to be in acceptable condition. The hardened steel rocking/pivoting inserts on all 3 layers will be check/replaced as necessary by the company performing the repairs during their overhaul.
4. The lower housing (Tub) was nearly full to the thrust runner with "sludge" consisting of Babbitt material and other solid particulate matter that has gained entry to the bearing over time. (See photos below)

Note fine galling over entire contact surface area. This is most likely a chronic effect of lack of filtration combined with the use of thinner lubricating oil.

It is our recommendation that the bearing be filled with ISO 680 or equivalent lubricant and circulated/filtered for a set amount of time daily, regardless of temperature. We have installed filtration units that come equipped with heating elements that can be used as necessary to maintain a minimum oil temperature regardless of ambient external temperatures. This practice alone can be the single biggest determining factor with regard to longevity of the bearing.

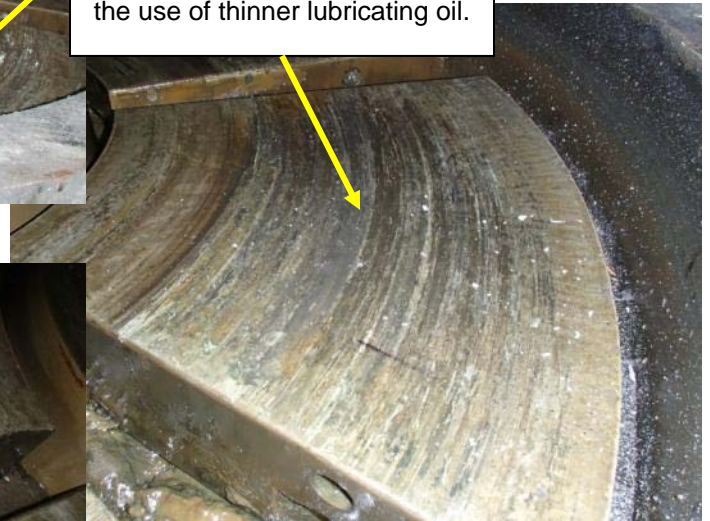
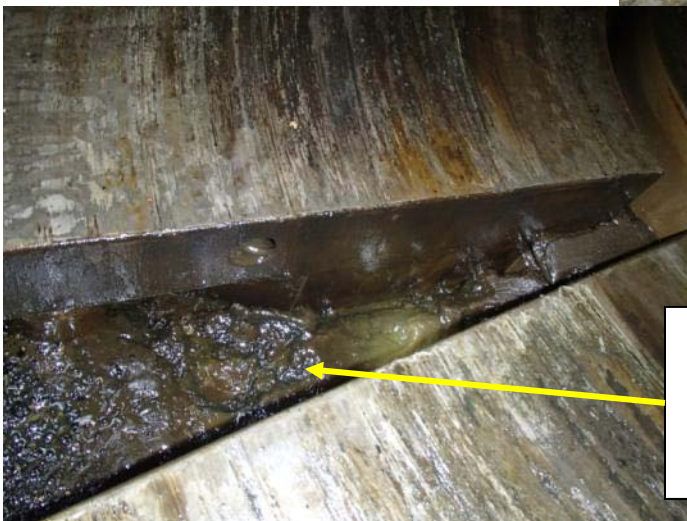
Accumulation of sludge and Babbitt material due to lack of circulation/filtration. Bear in mind that the bottom of the bearing tub is about 8-9" below the level shown.

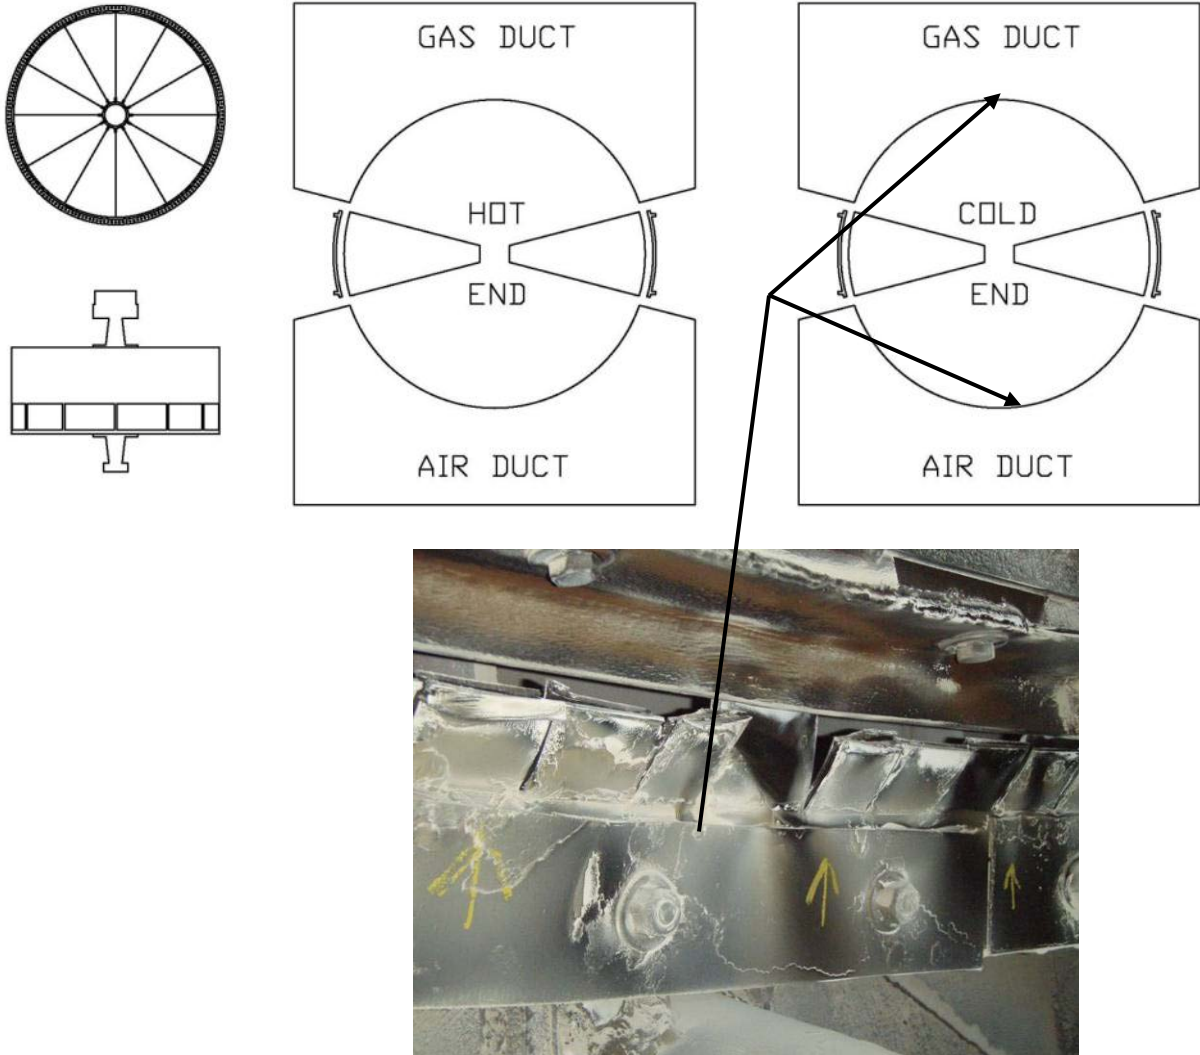
- **Area:** 2A Primary cold end both air and gas sides.
- **Action:** Replace Cold End Bypass seals.
- **Cause:** Erosion/Abrasion/ Contact wear
- **Repair:**
 - Replace cold end bypass seals. Seals are at the end of their effective service life.
 - Failing to replace these and other noted seals during this outage will most likely result in unsatisfactory leakage prior to the next scheduled outage.

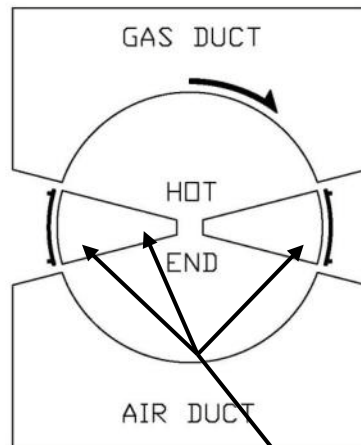
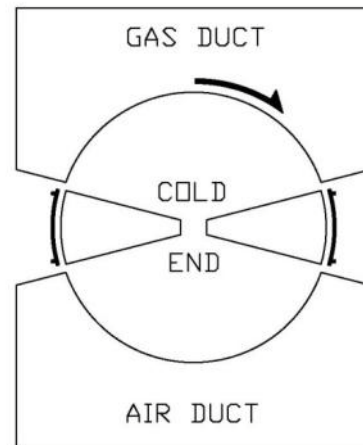
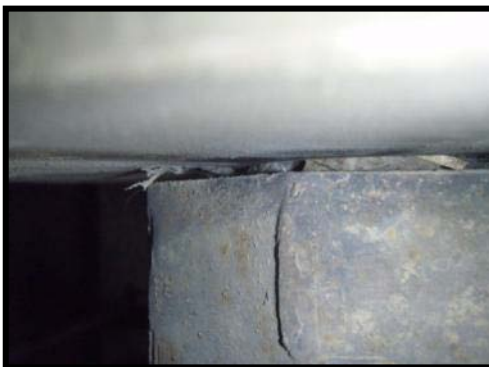
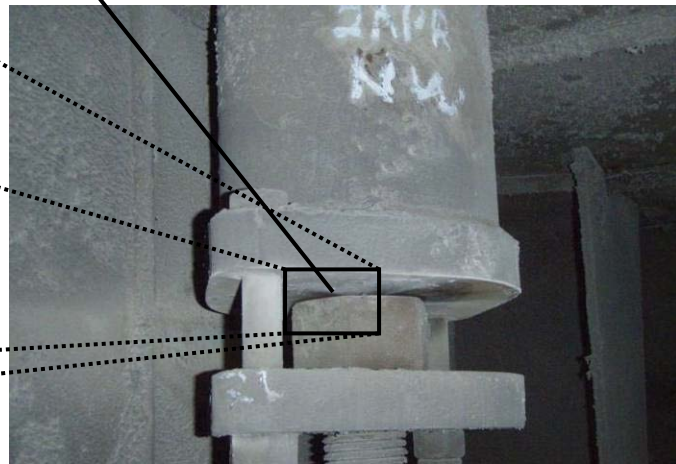
- **Area:** 2A Primary Sector Plate adjusting bolts.
- **Action:** Gaps between Keeper and Locknut. Tighten Keeper nuts to eliminate gap.
- **Cause:** Unknown.
- **Repair:** Gaps between Keeper and Locknut. Tighten Keeper nuts to eliminate gap. Do not change position of large locknut with respect to the adjusting bolt shank.

Locations: South side: Inboard, Outboard West. North side: Outboard West. Adjusting bolt "cans" that needed tightening were labeled with grease marker and tightened during the present outage. All adjusters should be checked periodically for tightness during operation.
