“3D” Inspection Report

**Unit 2 Airheaters
Outage May 7, 20XX**

**XXXXXXXXXX Co.
XXXXXXXXXX Station
Plant Contact: _____**

**By: XXXXXXXXXXX XXXXXXX
Field Services**

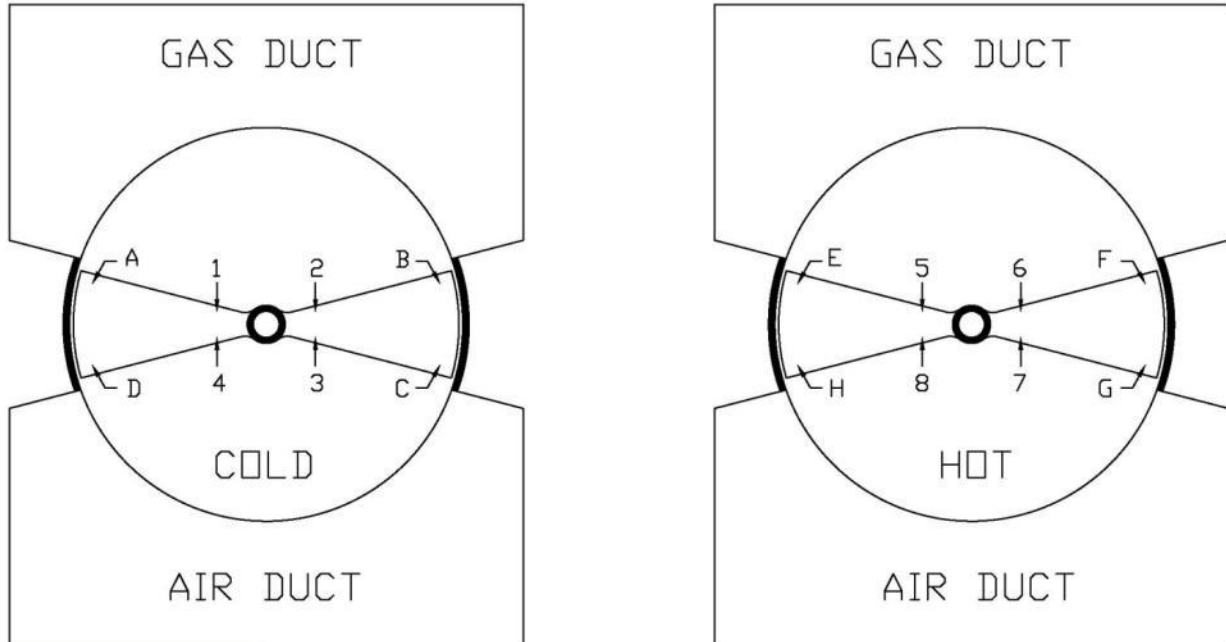
The above diagram indicates the measurement points taken during the Sector Plate

runout portion of the inspection. The rotation of all 4 Rotors is Clockwise as viewed from above the hot end. For the cold end measurements to make sense they will be recorded as though viewed looking downward through the Rotor.

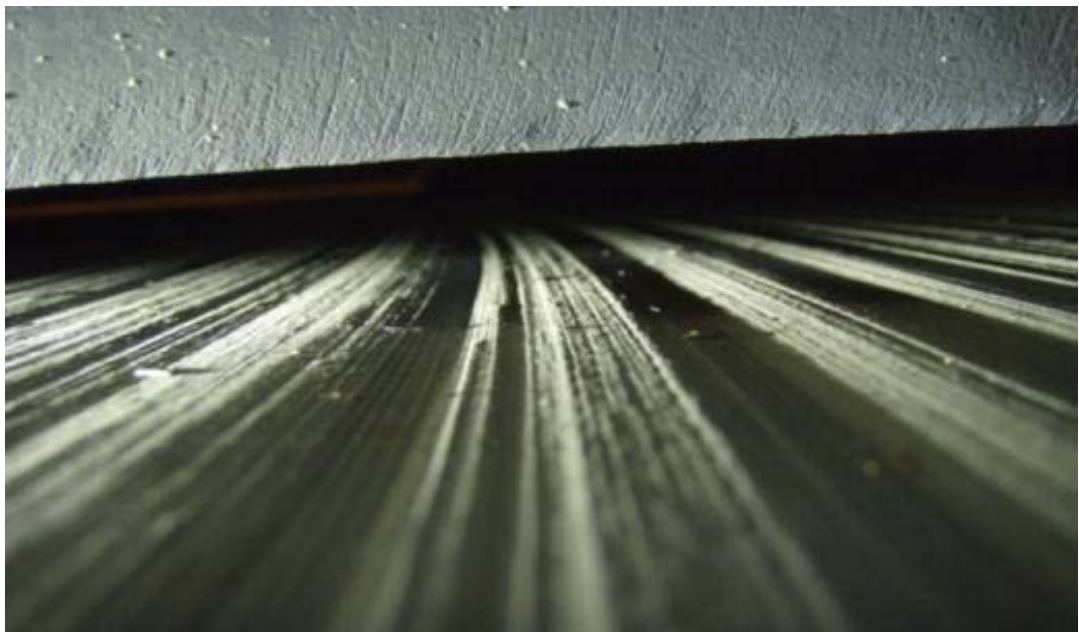
Unit 2B Sec Hot end (CW rotation Hot End View)			
Inboard Measurement		Outboard Measurement	
Location	Measurement	Location	Measurement
5	3/8"	E	1/4"
6	3/16"	F	1/8"
7	3/16"	G	3/16"
8	5/16"	H	1/4"
Inbd Runout	3/16"	Outbd Runout	1/8"
Unit 2B Sec Cold end (CW rotation Hot End View)			
Inboard Measurement		Outboard Measurement	
Location	Measurement	Location	Measurement
1	7/16"	A	1-1/8"
2	1/4"	B	1-5/16"
3	3/16"	C	1-1/4"
4	1/4"	D	1"
Inbd Runout	1/4"	Outbd Runout	5/16"

- “*” Indicates that the Sector Plate adjusting bolt below this area was found to be loose. The inboard adjusting bolt will have an effect on both inboard measurements for a given Sector Plate since it is the only mounting point for the nose of the plate.
- Hot and cold end Sector Plates were in good condition with relatively minimal signs of heavy contact wear or erosion.

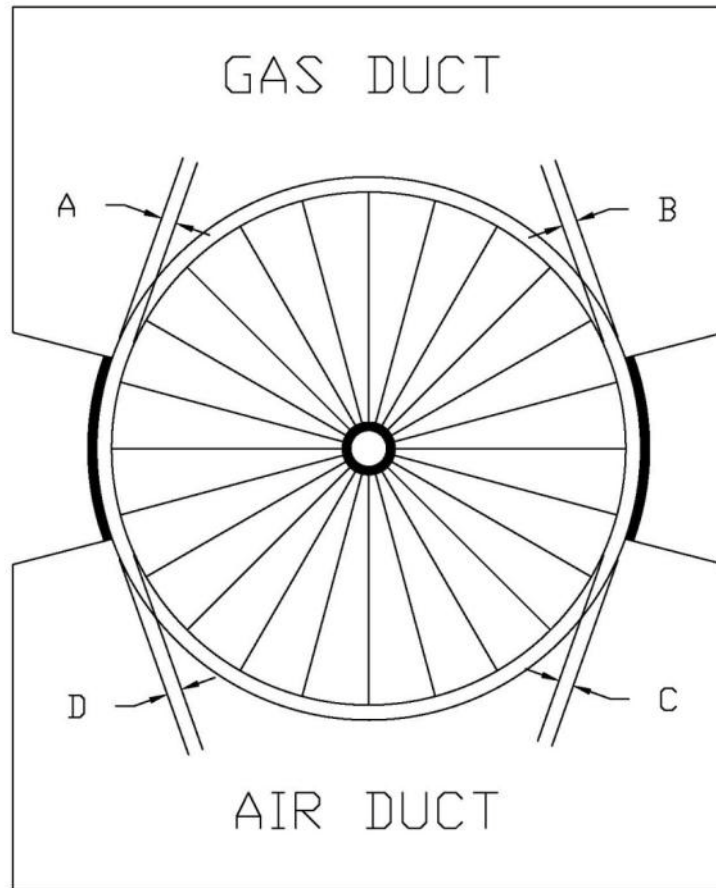
The above diagram indicates the measurement points taken during the Axial Seal Plate runout portion of the inspection. The rotation of all 4 Rotors is Clockwise as viewed from above the hot end. After each Rotor's measurements are given, I will briefly describe the noteworthy conditions.

Unit 2A Primary Axial Seal Plate Runout Measurements			
Location	Top	Middle	Bottom
A	7/16"	7/16"	11/16"
B	1/2"	7/16"	11/16"
C	7/16"	1/2"	3/4"
D	7/16"	3/8"	5/8"
Runout	1/16"	1/8"	1/8"
Unit 2A Secondary Axial Seal Plate Runout Measurements			
Location	Top	Middle	Bottom
A	7/8"	11/16"	9/16"
B	13/16	3/4"	5/8"
C	7/8"	3/4"	5/8"
D	7/8"	13/16"	3/4"
Runout	1/16"	1/8"	3/16"

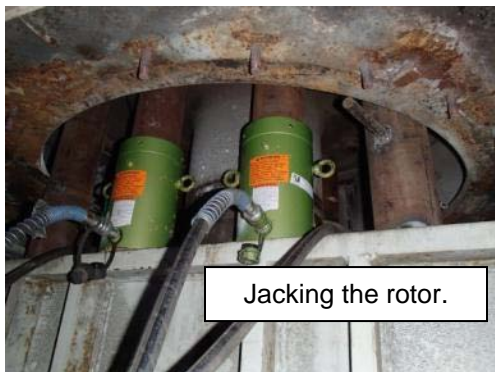
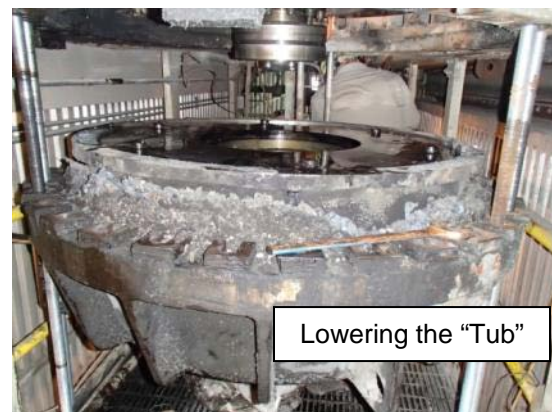
The rotor was isolated from all forms of energy (electric, thermal, pneumatic, Hydraulic, potential, etc.) and the rotor load removed from the thrust shoes. The lower bearing housing (Tub) was then lowered on 3 pairs of Gr. B2 all-thread to gain access to the thrust shoes, thrust runner, and upper/lower leveling plates (See photos below)

The thrust runner was removed and the internal components removed for inspection. Conditions of the internal components and housing were as follows:

1. Thrust shoes were finely galled over 100% of their contact area. (See Photos below).
2. Thrust runner was in good condition, with no immediate signs of damage to the wear surface. It is to be sent out for resurfacing with the shoes.
3. Upper/lower leveling plates and pivot rods appear to be in acceptable condition. The hardened steel rocking/pivoting inserts on all 3 layers will be check/replaced as necessary by the company performing the repairs during their overhaul.
4. The lower housing (Tub) was nearly full to the thrust runner with "sludge" consisting of Babbitt material and other solid particulate matter that has gained entry to the bearing over time. (See photos below)

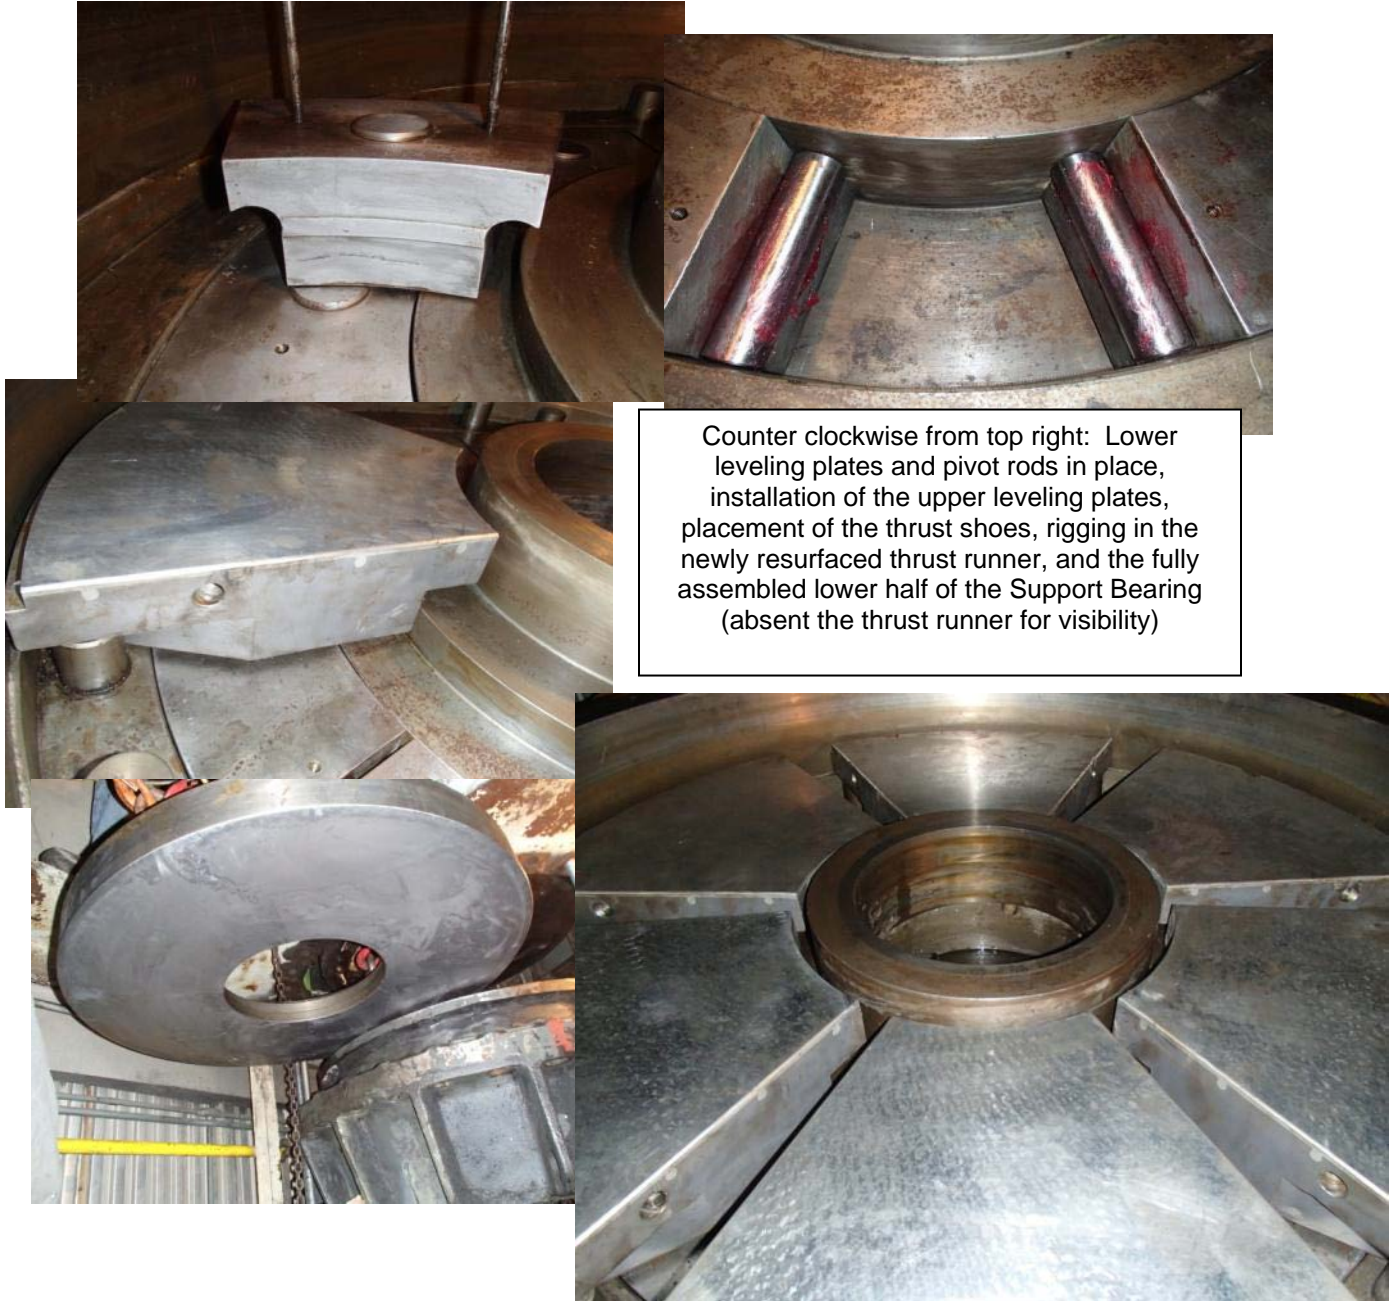
While it's true that this bearing was caught in time, before catastrophic failure, it appears to have been riding very close to the line mechanically. The use of thinner oil was recommended by the Air Preheater OEM to reduce the starting torque necessary to get the rotor turning after extended periods of inactivity. This condition may have accommodated its intended goals indefinitely if the unit was being circulated/filtered on a regular basis. As it stands, the fact that the bearing had not yet failed is little cause for rejoicing when there are three similar bearings adjacent to this one that have been under identical operating conditions.

The Support Bearing components were reworked and shipped back to the plant. After a thorough cleaning of the tub and a radial clearance measurement of the lower radial bearing, the internal components of the thrust bearing were reassembled. The tub was then raised and secured with new bolts torqued to manufacturer's specs. The rotor was then leveled in the housing, and appropriate adjustments made to the hot and cold end trunnion seals to accommodate the new rotor position. (See photos below)
